MERRIMACK RIVER BASIN  
BRISTOL , NEW HAMPSHIRE

INTERNATIONAL PACKINGS CORPORATION  
UPPER DAM  
NH - 00315

PHASE I INSPECTION REPORT  
NATIONAL DAM INSPECTION PROGRAM

APRIL 1979

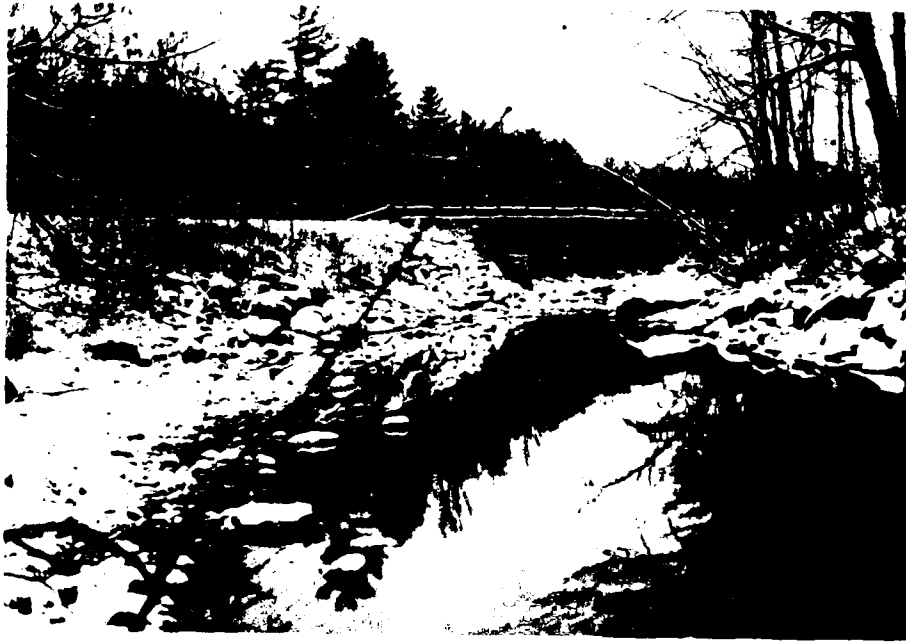
5

HIGHWAY BRIDGE DOWNSTREAM FROM DAM

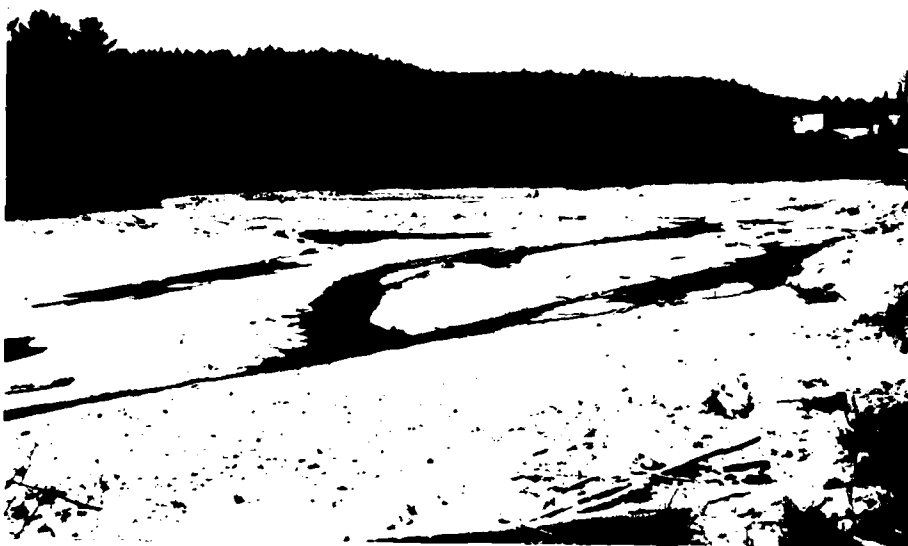
11

- d. Reservoir Area. No evidence of landslides in the reservoir area was observed during the inspection. Due to the flatness of the valley floor surrounding the reservoir, the potential for slope failure around the reservoir appeared minimal. There is a low-lying area along the reservoir shoreline approximately 100 feet upstream of the controlled outlet. There was some accumulated sediment within the reservoir basin, but it was not sufficient to obstruct the approach channel to the spillway or the controlled outlet. There are no buildings along the reservoir shoreline. The reservoir area is shown in Photographs 6, 10 and 11.

VIEW UPSTREAM FROM NEAR POWER HOUSE; RESERVOIR IS AT  
LOW WATER DUE TO CONTROL OF FLOW FROM NEWFOUND LAKE
